CONDITION SURVEY FOR PURCHASE

Name of vessel	Ti Malou
Hull identification number	BEY FR138K394/XA138
Registered port	Dover DE
Registered number	Not seen
Description	Beneteau Oceanis 440, Moorings 445 fiberglass aux diesel sloop, built in 1993 and is a 1994 model
Person requesting the survey	Brian Bennett
Persons present at survey	Mr D. Cooper for part of the time
Purpose of Survey	Condition for purchase by Mr Bennett
Date of Survey	19 November 2003
Date of report	20 November 2003
In water location	Road Harbour and the Sir Francis Drake Channel, Tortola, British Virgin Islands
Out of water location	Nanny Cay Yard, Tortola, British Virgin Islands
Mast Surveyed Aloft	Yes, no defects seen.
Estimated Value	Approximately \$80,000.00, see the last page of the report.
Estimated Replacement Value	Approximately \$250,000.00

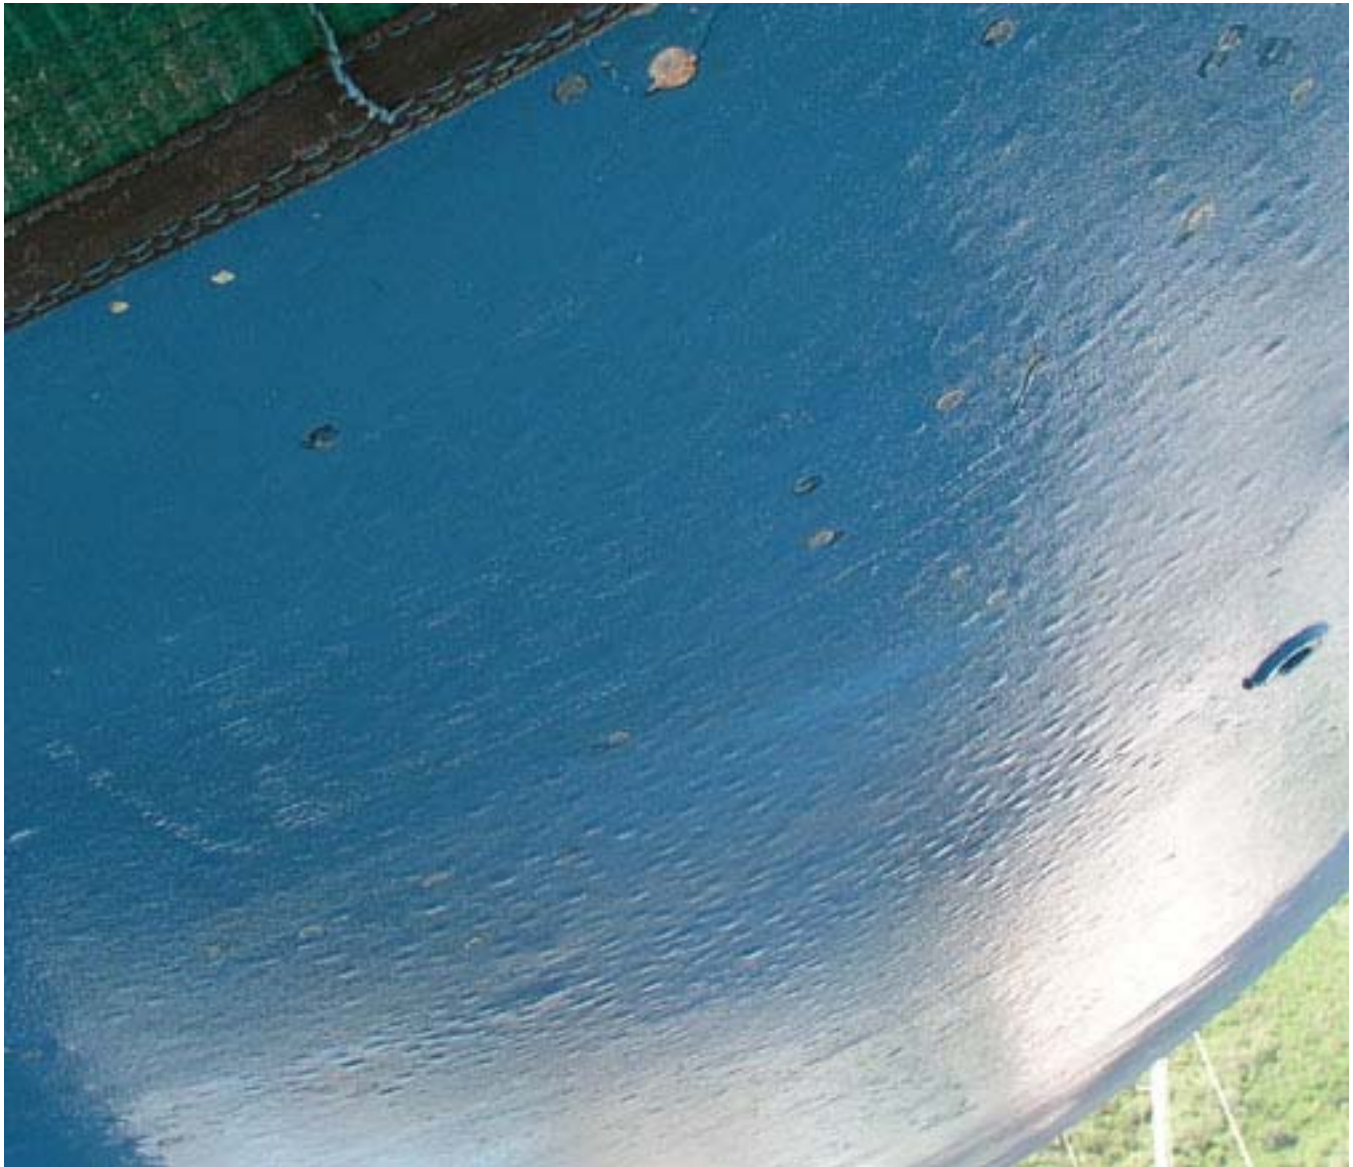
Moulded fiberglass. The liner is dis-bonded (about 12" x 12") in the starboard forward quarter and to port and starboard in the aft quarter approximately in line with the middle of the engine. We commonly find this with other similar 440 series and this is of no structural concern. There was no disbonding found elsewhere. There was no delamination found. There is extensive osmosis to the wetted surface. The blisters are mostly less than 1/2" diameter at about 3" intervals. There are 8 x 2' diameter blisters which are shallow and appear to be just under the gelcoat. The wetted surfaces need a full peel and treatment for osmosis

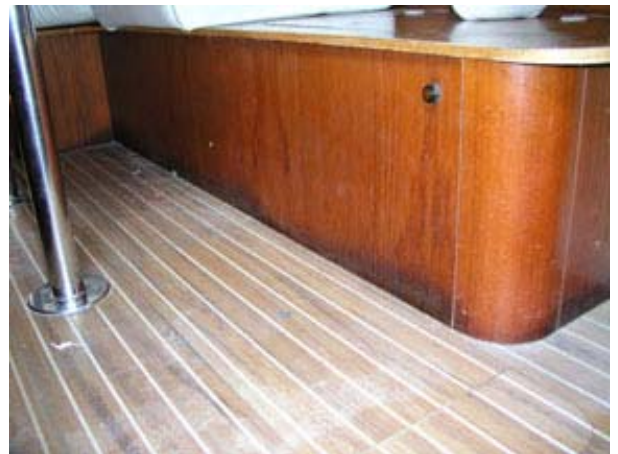
Plywood with veneers and Formica. The bottoms of most of the cabinet work is discoloured but not rotten. The cabinet work has been slightly displaced at the mast area. This is because the deck tie-down rod has been over tightened, pulling the aft side of the deck plate down and raising the front of the deck plate. This has caused the deck to flex but there are no stress cracks. The tie rod should be de tensioned and the deck allowed to settle back to normal. One hinge is missing from the door to the starboard fore cabin

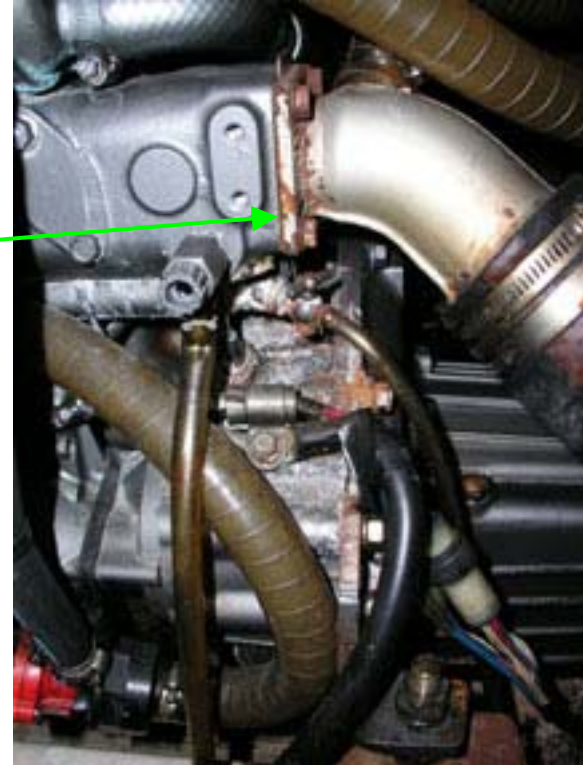
Wet with stainless steel waterlock. The water injection elbow has started to leak and will very soon need to be replaced. The heat exchanger resting on top of the gearbox is corroding and should be cleaned and preserved or it will need to be replaced in the near future, no other defects seen
