CONDITION SURVEY FOR PURCHASE

Name of vessel	Ti Malou
Hull identification number	BEY FR138K394/XA138
Registered port	Dover DE
Registered number	Not seen
Description	Beneteau Oceanis 440, Moorings 445 fiberglass aux diesel sloop, built in 1993 and is a 1994 model
Person requesting the survey	Brian Bennett
Persons present at survey	Mr D. Cooper for part of the time
Purpose of Survey	Condition for purchase by Mr Bennett
Date of Survey	19 November 2003
Date of report	20 November 2003
In water location	Road Harbour and the Sir Francis Drake Channel, Tortola, British Virgin Islands
Out of water location	Nanny Cay Yard, Tortola, British Virgin Islands
Mast Surveyed Aloft	Yes, no defects seen.
Estimated Value	Approximately \$80,000.00, see the last page of the report.
Estimated Replacement Value	Approximately \$250,000.00

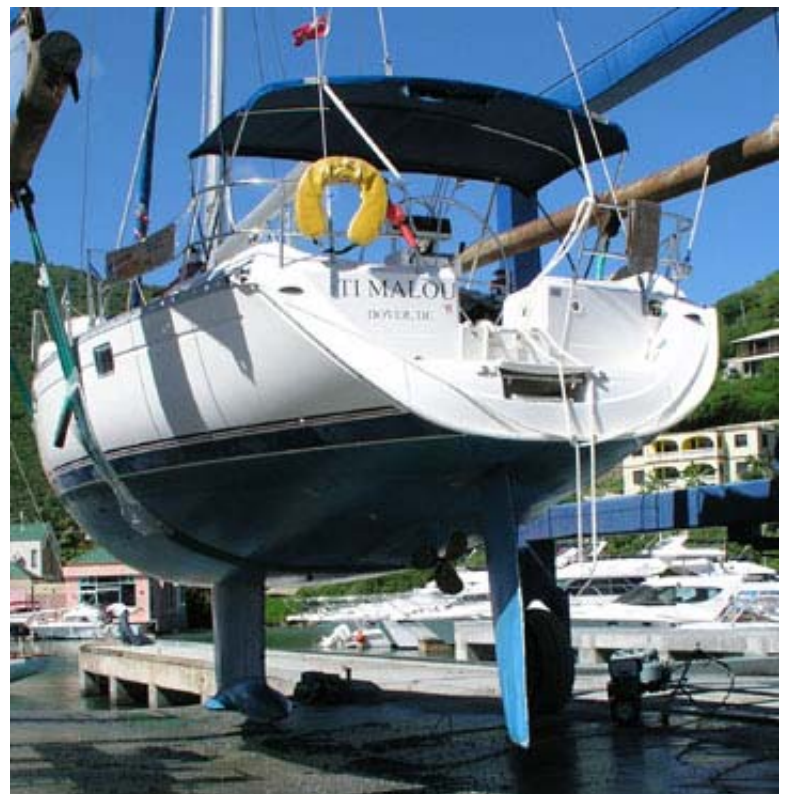
The vessel is considered to be in sound structural condition as far as can be determined without the removal of fittings and furnishings. Cosmetically, the vessel is showing signs of wear and tear consistent with 10 years of use in the charter industry
